28F400BX/BL
28F004BX/BL
28F200BX/BL
28F002BX/BL

SPECIFICATION UPDATE

Release Date: July 1996

Order Number 297187-008

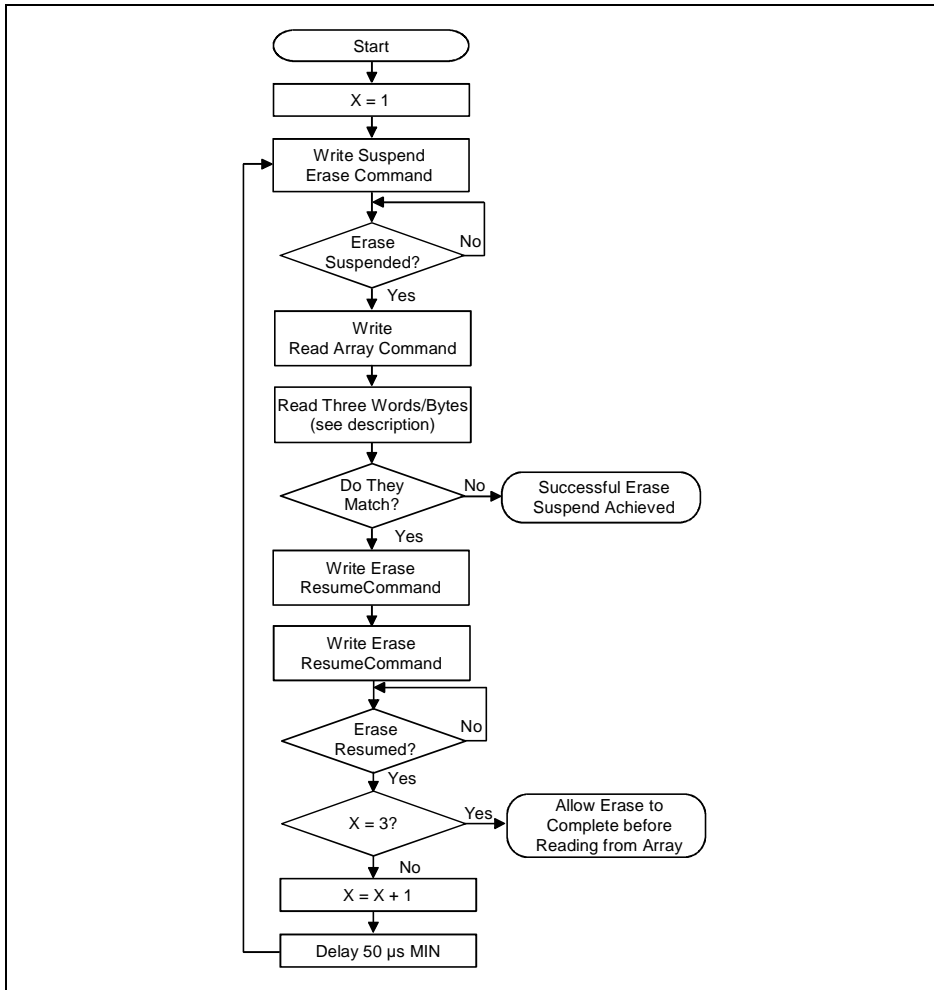
Erratum Identification/Resolution

PROBLEM: The 28F400/004/200/002BX/BL enter erase suspend mode when the Erase Suspend command is written to it (while the internal Write State Machine is executing an internal erase algorithm). Polling the Status Register and RY/BY# output will signal to the system that Erase Suspend has occurred. The device is now in erase suspend to status mode and writing the Read Array command will, **in most instances**, signal the device to output array data when read. The device enters a mode referred to as “erase suspend to array.” This allows system software to execute code or read data from blocks of the device.

Affected components in erase suspend to array mode will occasionally, after the Read Array command is written to them, output invalid array data due to an error in the State Machine circuitry. The device in this instance enters an invalid erase suspend mode and outputs invalid data bytes. Statistically, this has occurred approximately once every 500 erase suspend attempts.

WORKAROUND: The following procedure will reliably and consistently alert system software that the devices listed above have entered the invalid erase suspend mode. In almost all cases, this solution will also enable successful erase suspend. Reference the flowchart, *Erratum Identification/Resolution*, which follows, for a graphical description of the steps outlined:

- I. Write the Erase Suspend command to the device.
- II. Poll the Status Register to determine when Erase Suspend has been achieved.
- III. Write the Read Array command to the device.

- IV. Read three words/bytes of data from a block **other than that being erased**.
 - A. At least one of the three words/bytes should have a **known different value** compared to the other two. You must know that at least one of these words/bytes are different from the other two before writing the Erase Suspend command to the device. This can be determined by reading the device in normal read array mode.

- B. Hold device addresses A_0 – A_1 and A_{10} —Highest-Order-Address constant through the three reads.
 - C. Note: Highest-Order-Address =
 - A_{18} for 28F400BX, 28F400BX-L;

- A_{17} for 28F004BX, 28F004BX-L,
 - 28F200BX, 28F200BX-L;
 - A_{16} for 28F002BX, 28F002BX-L.
 - D. Toggle addresses A_2 – A_9 to access different word/byte locations for the three reads.

- V. If the values at these three locations **do not** match (as expected, because one of the words/bytes was determined to be different from the other two, before writing the Erase Suspend command), erase suspend to array mode has been entered successfully.

- VI. If the values at these three locations match, erase suspend to array mode has not been entered successfully on this attempt. Instead, the invalid erase suspend mode has been entered. Write the Erase Resume command to the device.
- VII. Read the device outputs (poll the Status Register) to determine when erase resumption has been achieved.
- VIII. Wait 50 μ s.
- IX. Re-execute the erase suspend attempt up to two more times (or three times total).
- X. If not successful after three attempts, issue the Erase Resume command, and allow the internal erase algorithm to complete before attempting to read from the array.

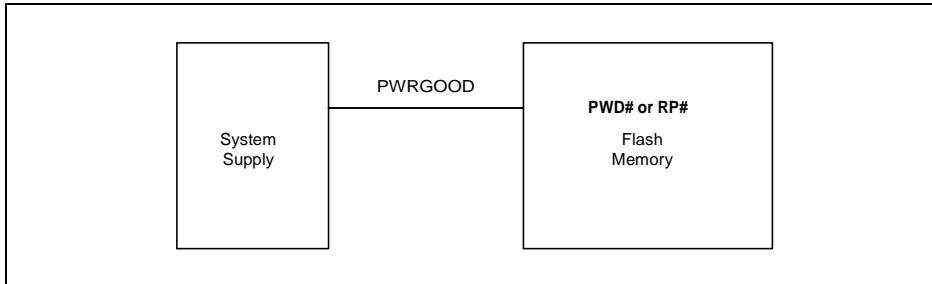
Using RP# for Protection against Spurious Command Writes

PROBLEM: The devices listed above do not meet the V_{LKO} , V_{CC} Erase/Write Lock Voltage, minimum specification of 2.0 volts when operating in **3.3V** mode. Instead, the described devices meet a minimum V_{LKO} voltage of **1.7 volts**.

To provide total protection from spurious writes, however, Intel recommends using the deep power-down/reset pin, RP#, to disable the flash memory during V_{CC} power transitions or reset operations.

To implement RP# write protection, RP# should be connected as shown in the figure below. The powergood (PWRGOOD) signal, available on most system supplies, goes low (active) when V_{CC} is removed from the system. When this occurs, RP# is forced low, the flash state machine is reset and the flash enters deep power-down mode where the flash is disabled regardless of the state of the other control pins. Upon V_{CC} power-up the power-good signal, and hence RP#, is forced high and the flash transitions to read array mode.

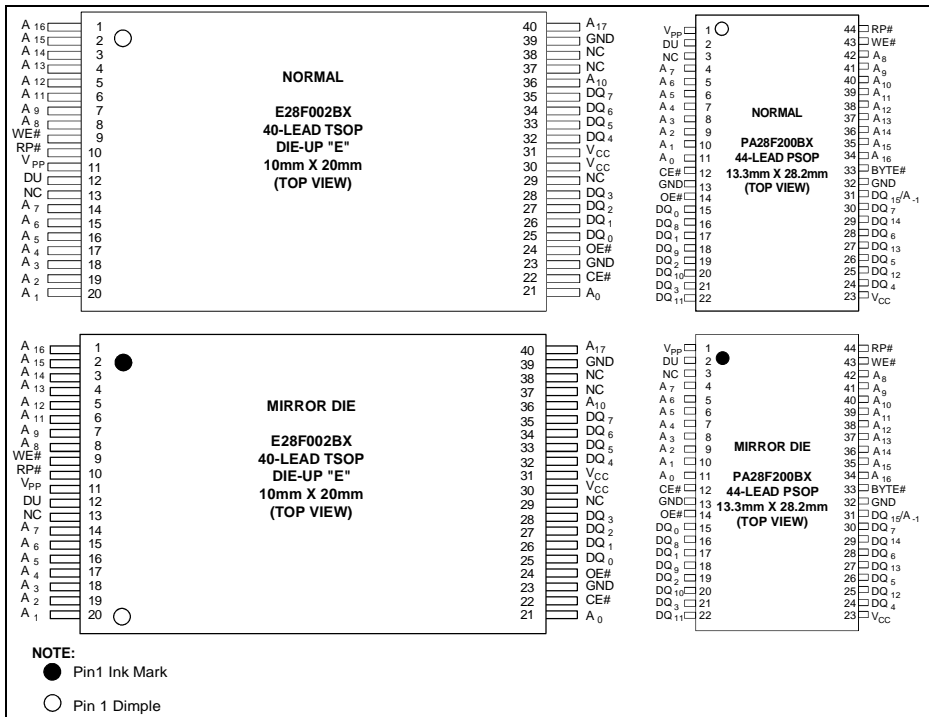
Pin Identification

PROBLEM: The die from the first few lots of the 28F200/002BX 2-Mbit Boot Block flash memory were mirror-imaged. These mirrored die have been qualified and found to be identical in every way to subsequent normal devices. However, some package markings had to be altered to identify this difference.

The 28F200/002BX is offered in the die-up TSOP and PSOP packages. Affected materials include both the 40-lead TSOP and the 44-lead PSOP packages. After some testing and package assessment, the mirrored die was inversely placed (i.e., built as die-down) in the die-up packages. A white dot is painted on the top, near the left-hand corner to indicate the position of pin 1. The distinguishing characteristics of these different package types are explained in the *Pin Identification* figure below.

Affected materials will be distinguished by an ink **mark** indicator for pin 1 in the upper left-hand corner of the device. All material not affected by this erratum will have the normal pin 1 dimple in the upper left hand corner. If the ink mark is present, the dimple should be ignored. There are some devices on which the ink mark indicating pin 1 is absent. If a device is suspected to be a mirrored-die product, please contact the local Intel representative for a replacement.
