Intel[®] 460GX Chipset

Specification Update

January 2002

Document Number: 249731-002

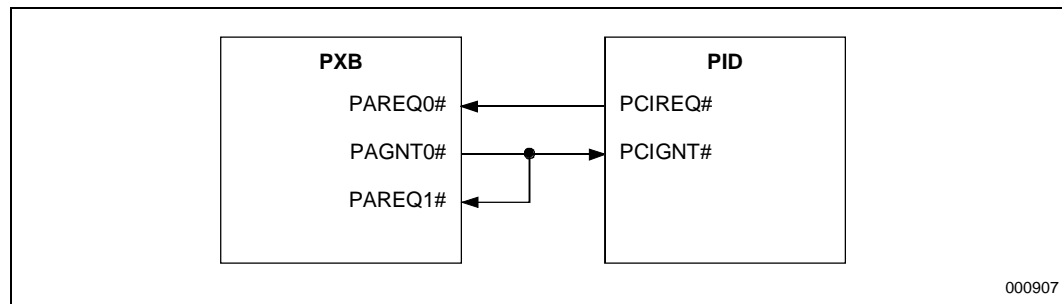
Figure 1. Recommended Workaround for Erratum 1

1. PID stops responding under certain conditions when PCI bus is parked on it

Problem: It is possible for the PID to stop responding when the following conditions are met:

Workaround: The workaround is to prevent the PCI bus from getting parked on the PID. With the PXB, it is accomplished by connecting the PID's PCI GNT# pin to an unused PCI REQ# input on the PXB that has the PID attached to it. See [Figure 1](#).

If no unused REQ# input is available on the PXB, the PID's PCI GNT# signal can be ANDed with another REQ# input.

This workaround results in the PXB always seeing a REQ# being asserted when the PID has been granted the bus, thus keeping the PCI bus from being parked on the PID. When the PID's GNT# signal is deasserted by the PXB, the REQ# line tied to it is also deasserted. If there are not any other outstanding requests for the PCI bus, the bus will be parked on the PXB since the REQ# signal and PID's GNT# signal get deasserted in the same clock.
