Intel® 82443MX PCIset

Specification Update

February 2003

Document number: 245051-008

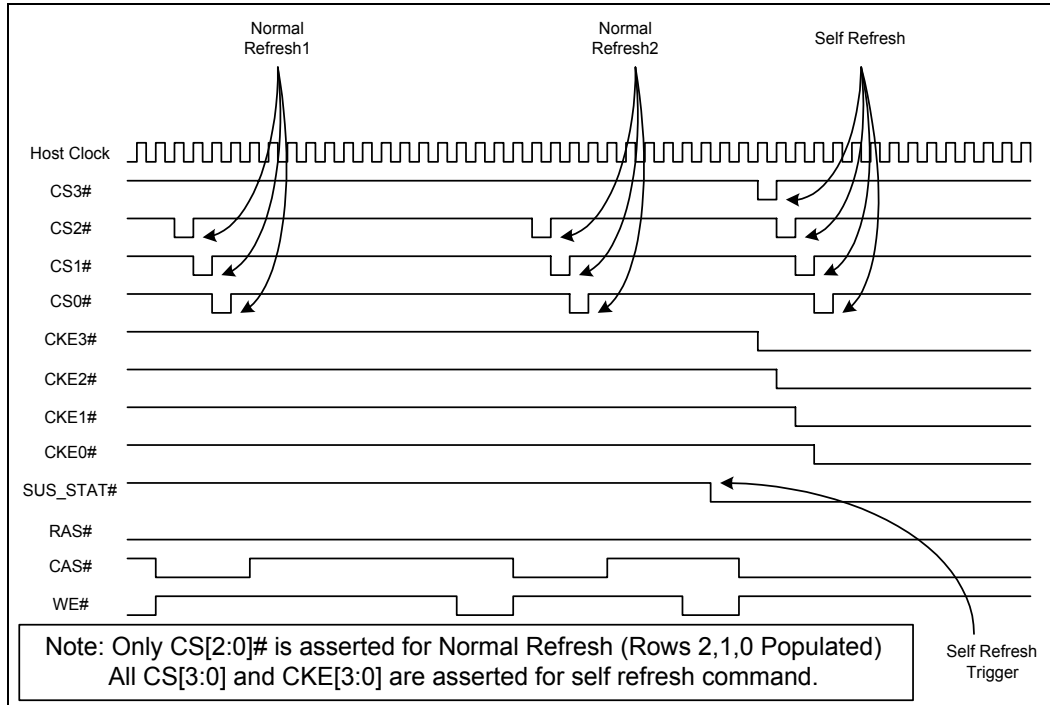
Figure 1: Successful Self-refresh Entry

Figure 1 illustrates a successful suspend entry sequence for a system which has rows 0, 1, and 2 populated. Note that for normal refresh, only the chip selects for the populated rows are asserted, whereas for the self-entry command, all four chip selects are asserted regardless of its population. Assume that dynamic SDRAM power-down feature is disabled. If all four rows are populated, it is impossible to capture this erratum.

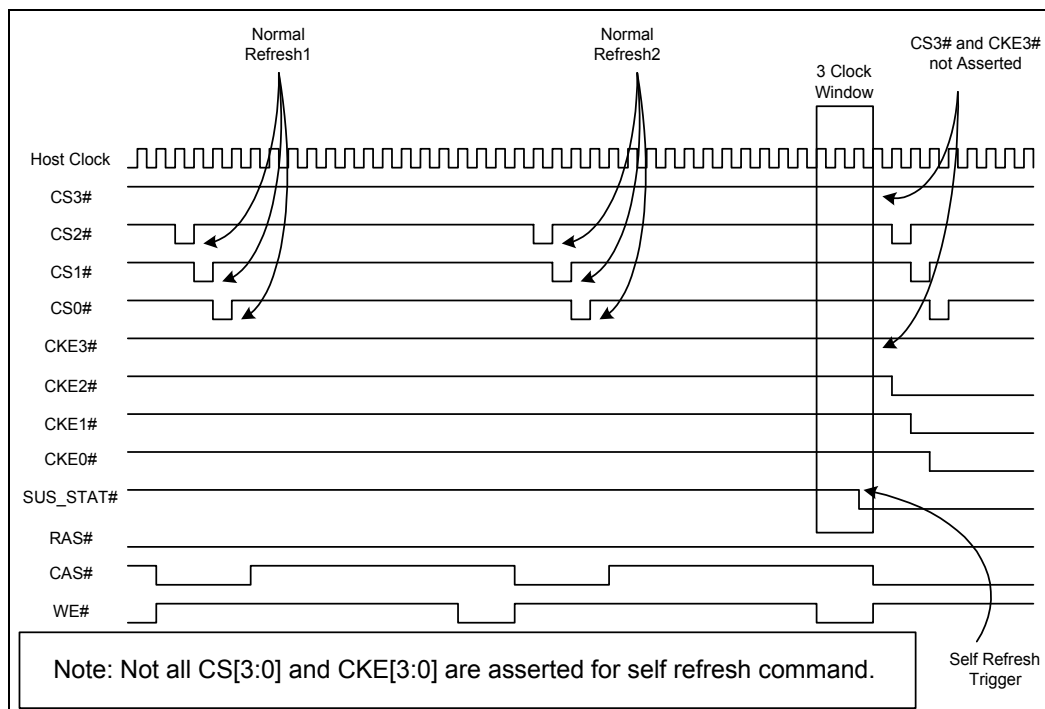
Figure 2: Unsuccessful Self-refresh Entry

Issue: SDRAM may be prevented from being put into self-refresh state when a self-refresh entry request triggered by SUS_STAT# assertion collides with a normal refresh caused by internal timer expiration. The collision between the two requests results in anomalous behavior on the CS[0-3]# and CKE[0-4]#, which can cause the system hang/memory corruption. There is a three Host clock window in which the assertion of SUS_STAT# can cause this failure.

Figure 2 illustrates an unsuccessful self-refresh entry sequence. Note that SUS_STAT# is being asserted approximately the same time that the third normal refresh would have taken place. Since the SUS_STAT# assertion hits the three host clock window, CS3# and CKE3# do not get asserted during the self-refresh entry sequence.

Implication: The system may hang if an unsuccessful self refresh entry sequence occurs.

Workaround: Please refer to the SDRAM Suspend Refresh Erratum APM Workaround Write-up, Rev 1.0 for a software workaround solution.

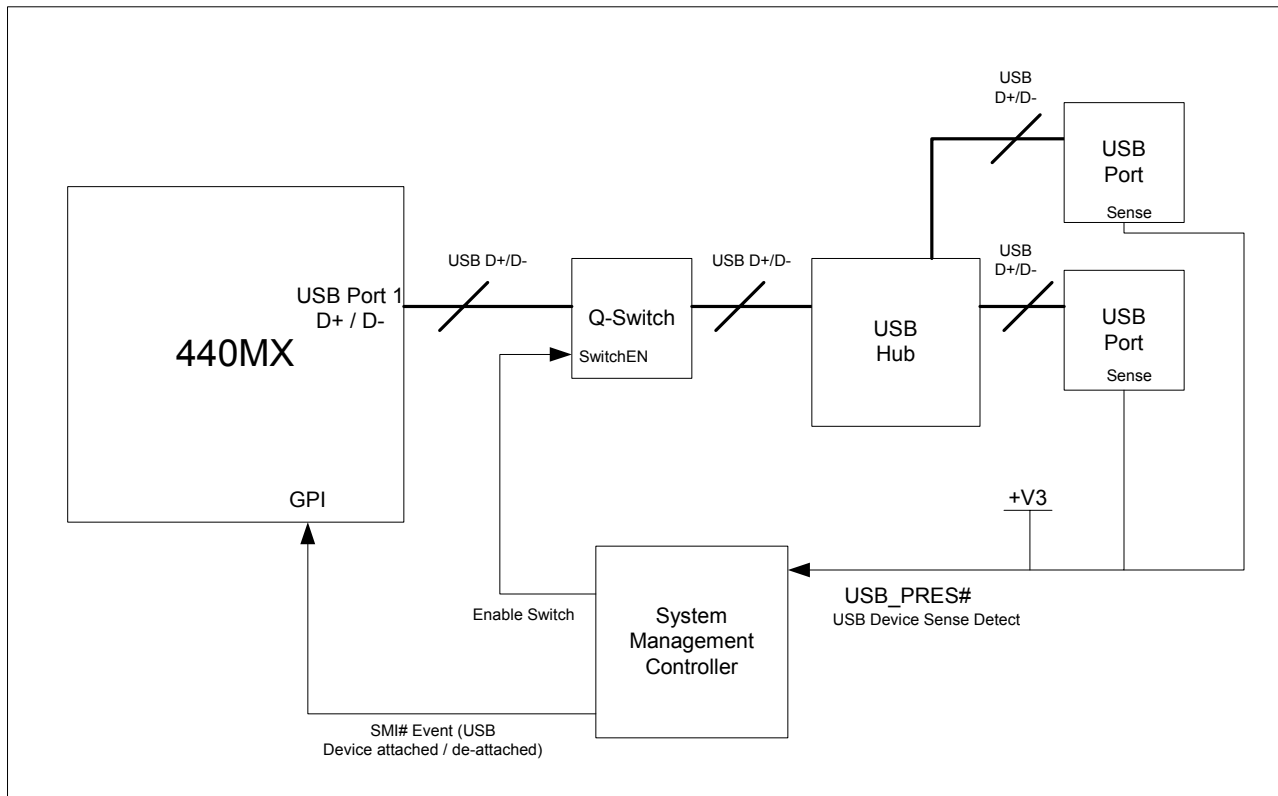
Figure 3: Errata 33, Workaround #4: USB Device Attach/De-attach - Hardware Solution

Implication: The USB device will not be detected under the above condition. This may result in a no Plug and Play operation of the affected USB device
