82380AB (MISA) Docking PCIset

Specification Update

March 1999

Order Number: [297657-001](#)

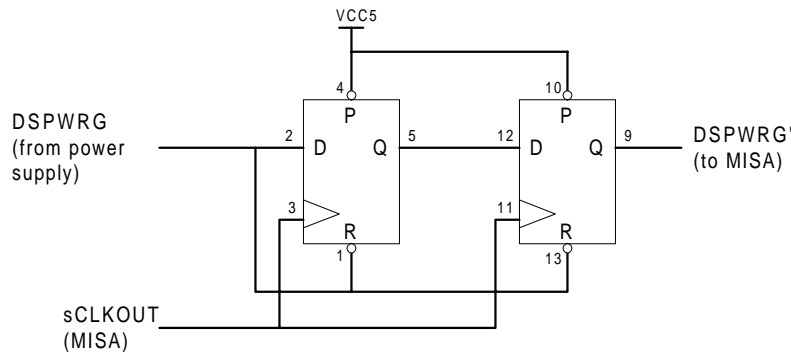
1. DSPWRG must be synchronized.

Problem: DSPWRG does not reset the device as expected if the PCICLK is not running when DSPWRG is asserted.

Implication: The MISA device will not function correctly.

Workaround: The following circuit will delay DSPWRG until PCICLK is running at MISA.
