# **Intel® Desktop Board D865GRH Specification Update**

Release Date: November 2004

Order Number: C59427-007

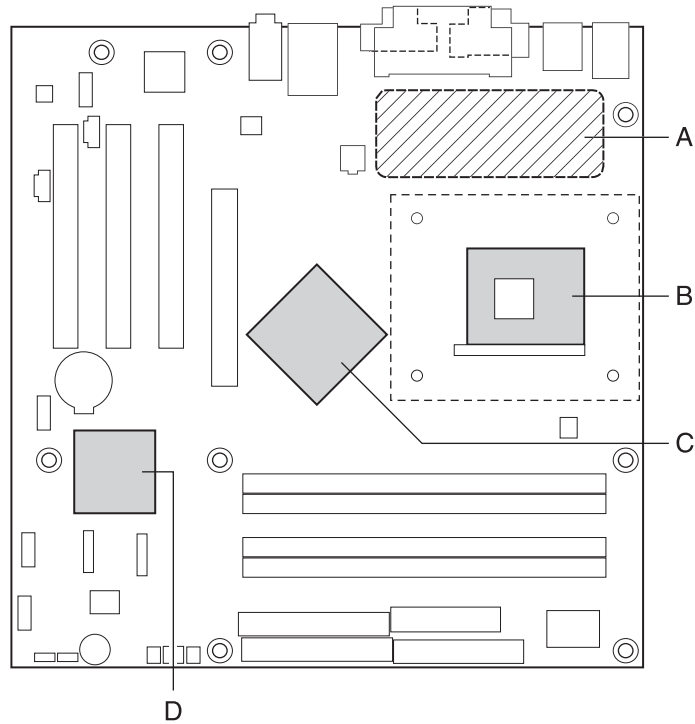
**Figure 26. Localized High Temperature Zones**

*Ensure that proper airflow is maintained in the processor voltage regulator circuit. Failure to do so may result in damage to the voltage regulator circuit. The processor voltage regulator area (item A in Figure 26) can reach a temperature of up to 85 °C in an open chassis.*

Figure 26 shows the locations of the localized high temperature zones.
