Monthly Specification Update

Intel® Server Board S500VSA SATA

Intel Order Number E57949-004

November, 2009

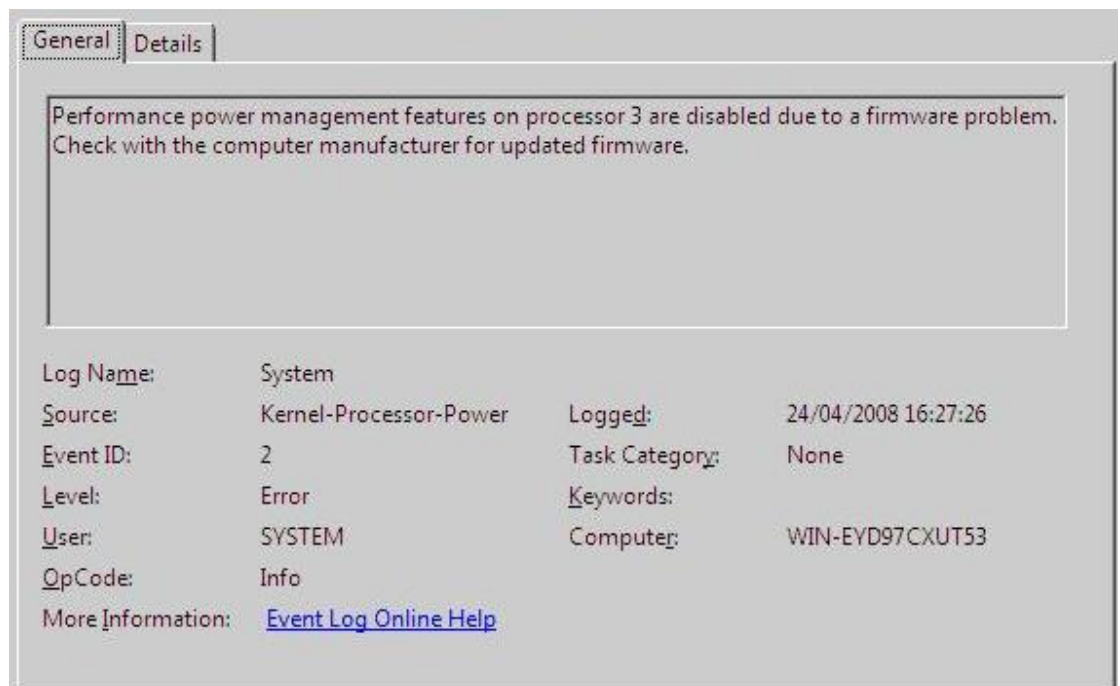
Problem: If you use any Intel® Xeon® Processor of the 5300 or the 5400 series in the Intel® Server Board S5000VSA and install Microsoft Windows Server 2008* on the system, you may encounter the following error in the Windows* event log:

The Event Error is generated due to a change in Microsoft’s validation and logging of supported P-States for a processor. The wording of the error is misleading. There is no performance impact. Microsoft is logging the error because the BIOS has a default PSS object (P-State info) in the ACPI space for these processors. Basically, this default PSS object indicates no P-State is supported. However, Microsoft Windows Vista* and Microsoft Windows Server 2008* have changed the interpretation of this table.

Implication: BIOS version 88 or even an earlier version may produce this erratum.
