Monthly Specification Update

Intel® Workstation Board S5520SC

Intel Order Number E68106-021

May, 2011

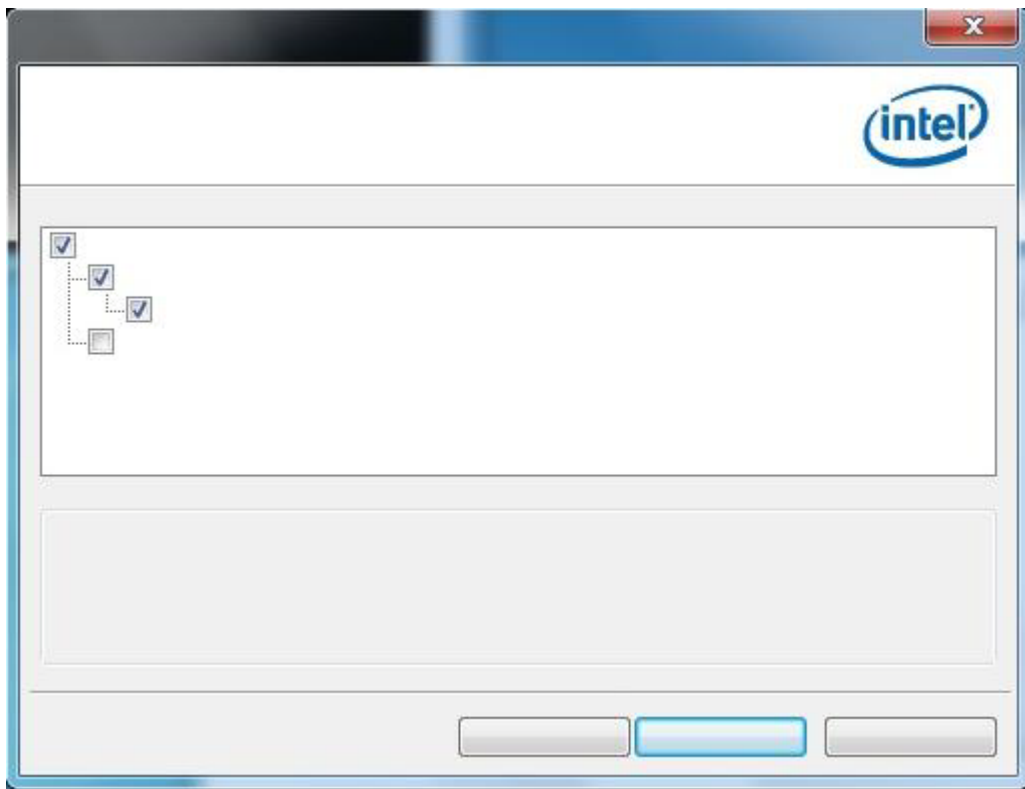
30. NIC driver 15.1.1 may not be installed properly in Microsoft Windows Vista* or Microsoft Windows 7*

Problem	Users may find onboard NIC (Network Interface Card) driver version 15.1.1 may not get installed properly in Microsoft Windows Vista* or Microsoft Windows 7* when UAC (User Access Control) is set as "Default". Problem may occur during the installation process of the NIC driver, scramble display and unexpected message may display as following:
---------	---

- Implication** This is a permissions issue with Microsoft Windows Vista* and later operating systems. Permissions don't get elevated installing with PROSETDX.MSI, which is the file the batch file in the root directory points to. DXsetup gets the permissions elevated on Microsoft Windows Vista* and later operating systems, but they don't get elevated if you launch the MSI without DXsetup.
- Status** This issue will be fixed by future NIC driver release.
- Workaround** The following workaround can be used to navigate around the issue.
1. Users can browse to the \apps\prosetdx\ - 2. Users can also refer to below picture to set Windows UAC (User Account Control) to "Never notify", re-install the driver after a system reboot.
