# Monthly Specification Update

## *Intel® Workstation Board S5520SC*

*Intel Order Number E68106-023*

**July, 2011**

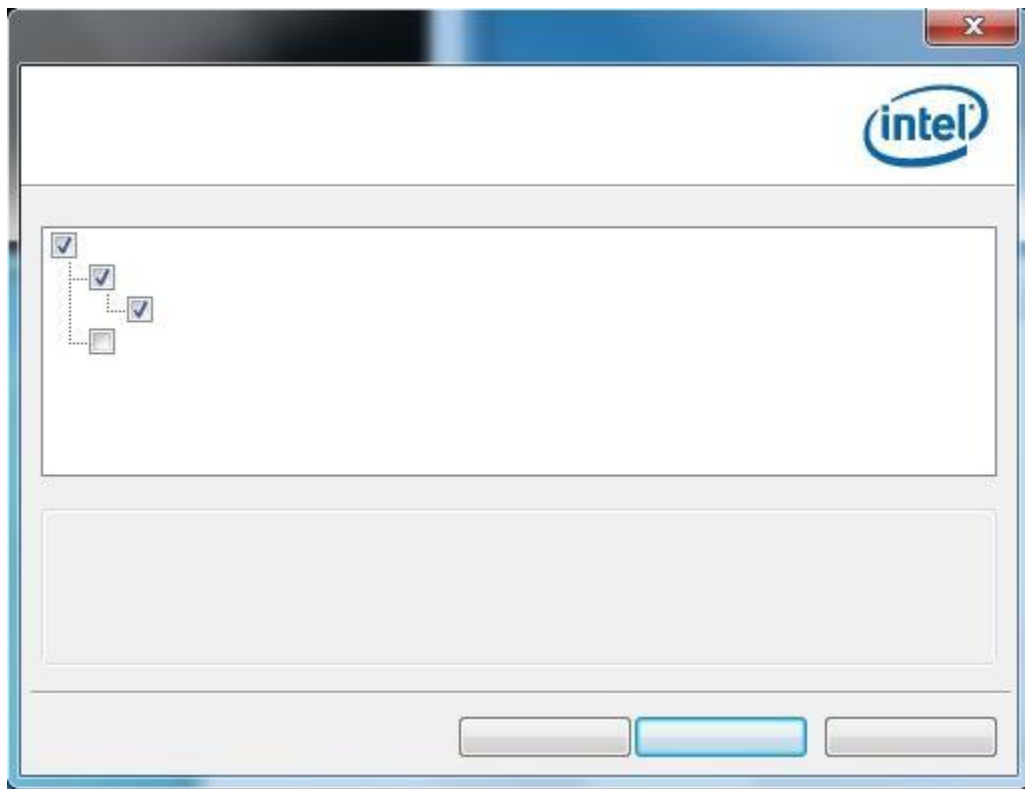
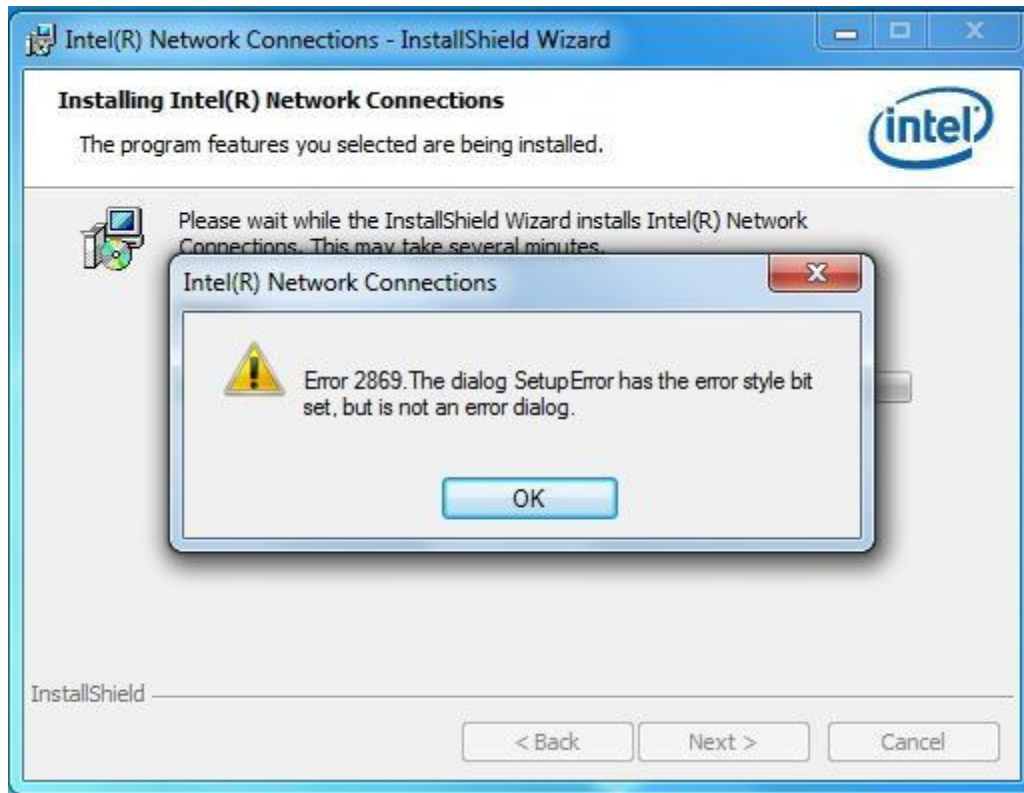
Problem	Users may find onboard NIC (Network Interface Card) driver version 15.1.1 may not get installed properly in Microsoft Windows Vista* or Microsoft Windows 7* when UAC (User Access Control) is set as "Default". Problem may occur during the installation process of the NIC driver, scramble display and unexpected message may display as following:
---------	---

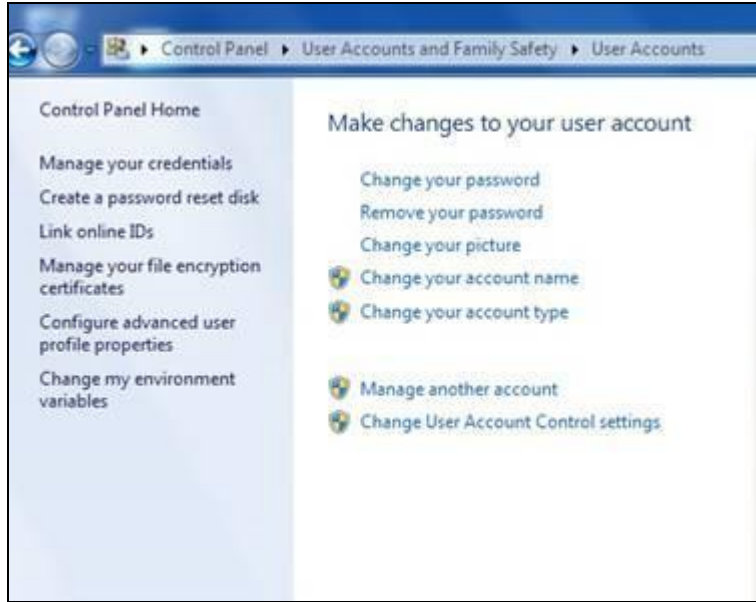
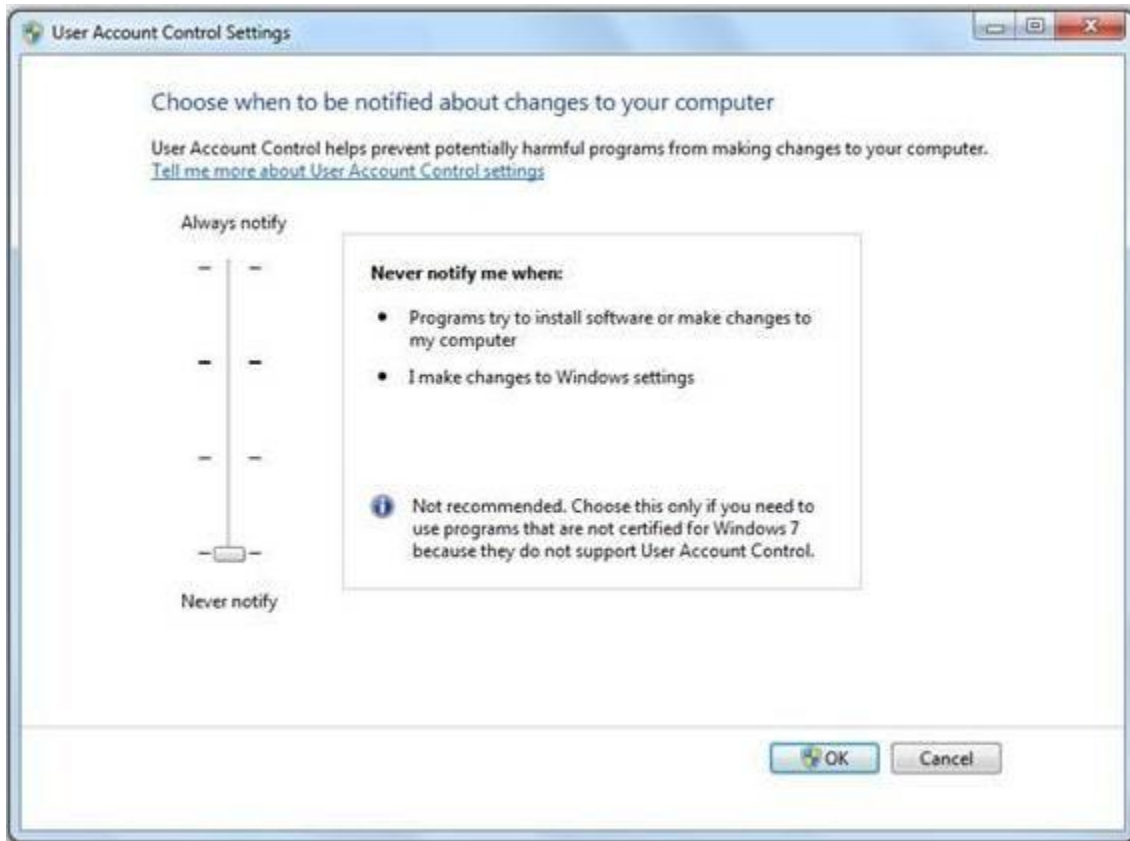
- Implication** This is a permissions issue with Microsoft Windows Vista\* and later operating systems. Permissions don't get elevated installing with PROSETDX.MSI, which is the file the batch file in the root directory points to. DXsetup gets the permissions elevated on Microsoft Windows Vista\* and later operating systems, but they don't get elevated if you launch the MSI without DXsetup.
- Status** This issue will be fixed by future NIC driver release.
- Workaround** The following workaround can be used to navigate around the issue.
1. Users can browse to the \apps\prosetdx\  - 2. Users can also refer to below picture to set Windows UAC (User Account Control) to "Never notify", re-install the driver after a system reboot.
