Monthly Specification Update

Intel® Server Board S5520UR

Intel Order Number E69054-001

December 2010

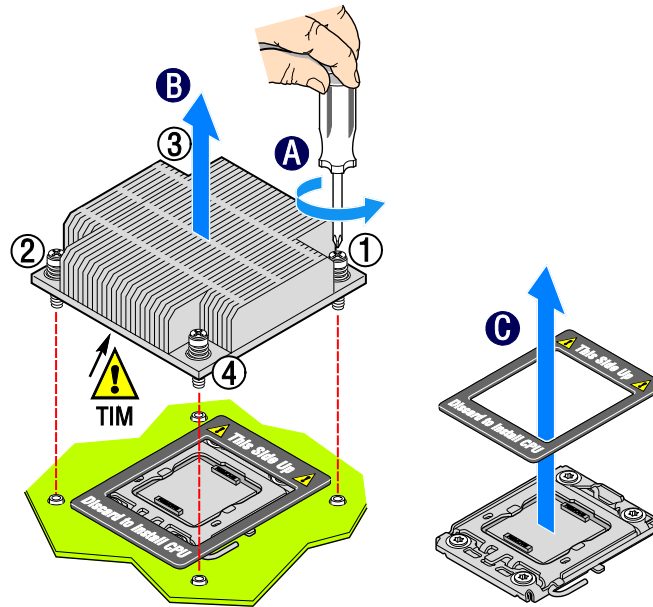
Figure 1. Removing the Heatsink

- Problem:** The current documentation does not properly describe the installation and removal of the heatsink. Careful insertion and removal of the heatsink is required to prevent damage to the heatsink screws or backplate.
- Implication:** There is a possibility of damage to the heatsink if proper steps are not followed.
- Status:** Corrections incorporated into the latest version of the following Service Guides:
- Intel® Server System SR1600 Service Guide (Intel Order Number: E52880-003)
 - Intel® Server System SR1625 Service Guide (Intel Order Number: E52881-003)
 - Intel® Server System SR2600/SR2625 Service Guide (Intel Order Number: E51243-003)
- Workaround:** Perform the steps outlined below for installation and removal of the heatsink to avoid damage.

1. Loosen the four captive screws on the heatsink corners in a diagonal manner according to the numbers shown in figure 1 as follows:
 - Starting with the screw at location 1, loosen it by giving it **two rotations** in the anticlockwise direction and stop. (**IMPORTANT:** Do not fully loosen.)
 - Proceed to the screw at location 2 and loosen it by giving it two rotations and stop.
 - Loosen screws at locations 3 and 4 by giving each screw two rotations and then stop.
 - Repeat steps 1a through 1c by giving each screw two rotations each time until all screws are loosened.
2. Do one of the following:
 - If removing the heatsink for the first time, do the following:
 - i. Lift the heatsink from the board.
 - ii. Remove and discard the spacer (see letter “C” in figure 1).

- If a processor is already installed, do the following:
 - i. Twist the heatsink slightly to break the seal between the heatsink and the processor.
 - ii. Lift the heatsink from the processor. If it does not pull up easily, twist the heatsink again. Do not force the heatsink from the processor. Doing so could damage the processor.
