Monthly Specification Update

Intel® Server Board S5520UR

Intel Order Number E69054-001

January 2012

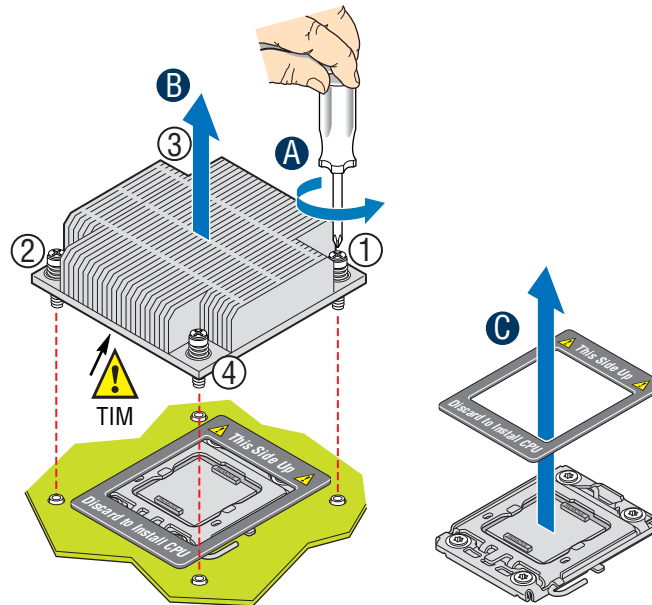
Figure 1. Removing the Heatsink

- Problem:** The current documentation does not properly describe the installation and removal of the heatsink. Careful insertion and removal of the heatsink is required to prevent damage to the heatsink screws or backplate.
- Implication:** There is a possibility of damage to the heatsink if proper steps are not followed.
- Status:** Corrections incorporated into the latest version of the following Service Guides:
- Intel® Server System SR1600 Service Guide (Intel Order Number: E52880-003)
 - Intel® Server System SR1625 Service Guide (Intel Order Number: E52881-003)
 - Intel® Server System SR2600/SR2625 Service Guide (Intel Order Number: E51243-003)
- Workaround:** Perform the steps outlined below for installation and removal of the heatsink to avoid damage.

1. Loosen the four captive screws on the heatsink corners in a diagonal manner according to the numbers shown in figure 1 as follows:
 - Starting with the screw at location 1, loosen it by giving it **two rotations** in the anticlockwise direction and stop. (**IMPORTANT:** Do not fully loosen.)
 - Proceed to the screw at location 2 and loosen it by giving it two rotations and stop.
 - Loosen screws at locations 3 and 4 by giving each screw two rotations and then stop.
 - Repeat steps 1a through 1c by giving each screw two rotations each time until all screws are loosened.
2. Do one of the following:
 - If removing the heatsink for the first time, do the following:
 - i. Lift the heatsink from the board.
 - ii. Remove and discard the spacer (see letter “C” in figure 1).
