# intel® Technical Advisory

TA-561-1

May 22, 2002

## CDROM Drive "Door Sticking", corrected with Manufacturing Deviation

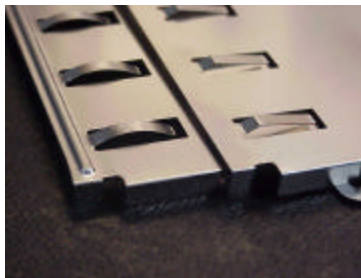
The assembled system has insufficient margin between the top flange of the chassis's' media bay and the top cover of the CDROM.

- The Mitsumi CDROM has less ejection force than Teac drives.
- Upper EMI shield (PNs A70866-003, A70866-002) has spring fingers that are too stiff for the gap resulting in excessive force/deflection on the top of the CDROM.

EMI Shield Front Corners  
(Pictured Left: -004) (Pictured Right: -003)

- TSRMT2 systems will be manufactured with Teac CDRROM drives. This change is being implemented immediately via a Manufacturing Deviation, and will be ECO'ed into the product.
- The EMI shield design has been modified in two ways: an emboss was added to give the span of the EMI shield stiffness to resist spring force, and spring geometry was changed to reduce the force on the top cover of the CDRROM. The part number of modified EMI shield design has rolled to A70866-004. The -004 shield has been implemented immediately via a Manufacture Deviation, and will be ECO'ed into the product.
