Intel Technical Advisory

TA-0983-1

July 28, 2011

MiniSAS-to-SATA cable SGPIO connector incompatible with Hot Swap Backplanes FUP4X35HSBP / FR1304HSBP

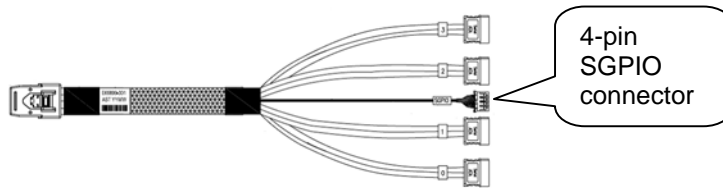
The current cable (E65899-001) for the listed RAID controllers has a 4-pin SGPIO connector.

The 4-pin SGPIO connector of the E65899-001 cable cannot be plugged into the 5-pin SGPIO connector of the backplanes or systems listed above. Without the SGPIO cable connected, the listed backplane fault LED will not function with the Intel® RAID Controllers listed above.

The SGPIO connector on the backplanes or systems listed above is a 5-pin connector. The SGPIO connector on the E65899-001 cable is a 4-pin connector. The E65899-001 cable was designed before the backplanes or systems listed above were released and is not compatible with the backplanes or systems listed above.
