# Intel<sup>®</sup> Celeron<sup>®</sup> Processor Specification Update

Release Date: December 2006

Document Number: 243748-048

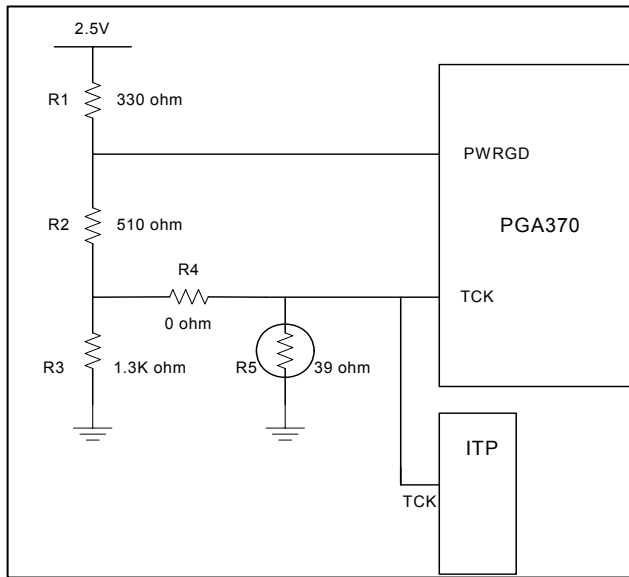
Figure 1 Celeron® on 0.13 Micron Processor 256K Platforms Workaround

In addition, the example workaround circuits shown do not support production motherboard test methodologies that require the use of the processor JTAG/TAP port. Alternative workaround solutions must be found if such test capability is required.

For Production Boards:

*Depopulate R5*
