Mobile Intel[®] Pentium[®] II Processor Specification Update

Release Date: December 2006

Order Number: 243887-057

The Mobile Pentium[®] II processor may contain design defects or errors known as errata which may cause the product to deviate from published specifications. Current characterized errata are documented in this Specification Update.

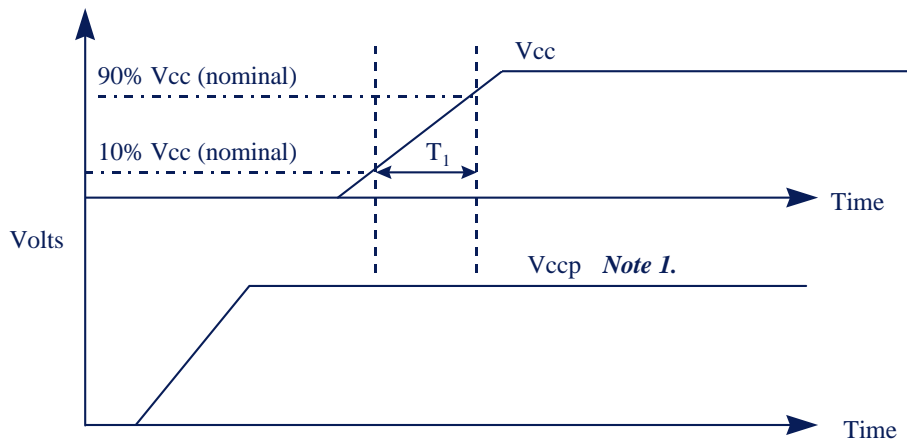
Figure 1. V_{CC}/V_{CCP} Timing Requirements (Mobile)

Problem: The processor uses the PWRGOOD signal to ensure that no voltage sequencing issues arise; no pin assertions should cause the processor to change its behavior until this signal is asserted, when all power supplies and clocks to the processor are valid and stable. However, if V_{CC} ramps up before V_{CCP} , it will cause the processor to enter an invalid state.

Implication: If this erratum occurs, the system may boot normally however, the L2 cache may not be initialized.

Workaround: For Mobile Pentium II processors, ensure that V_{CC} ramps after or with the L2 cache IO voltage (V_{CCP}). If V_{CCP} ramps after the V_{CC} , a delay circuit can be placed on the core V_{CC} to ensure that V_{CC} ramps at the same time or after V_{CCP} as shown below in Figure 1.

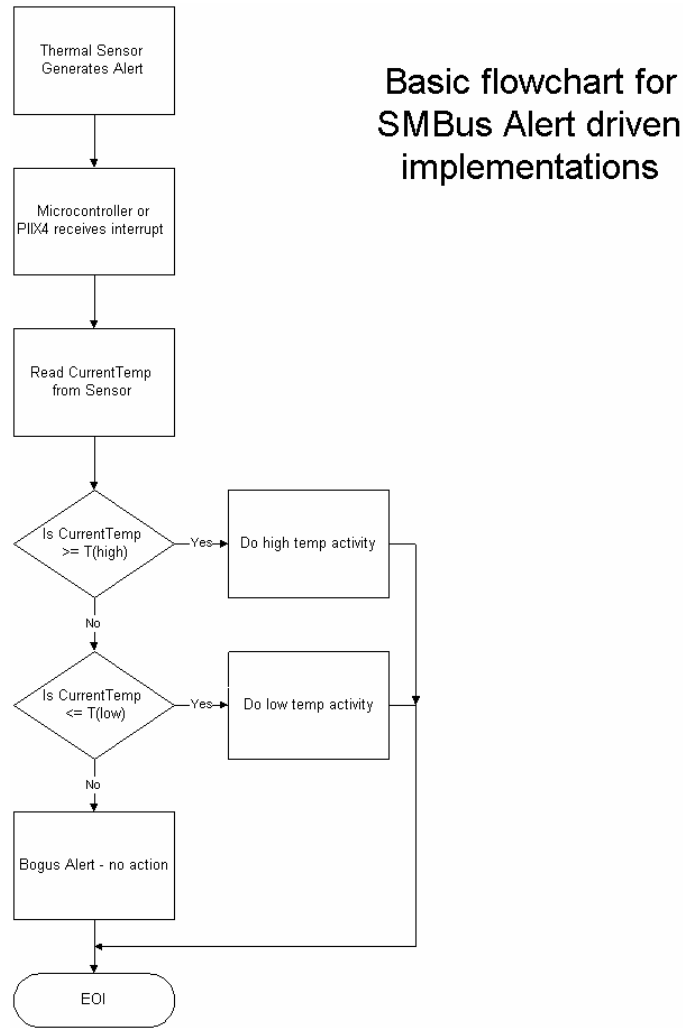
Figure 2. Workaround Flowchart: SMBALERT#-Driven System

Under the conditions described below, the thermal sensor incorrectly generates the SMBALERT# interrupt. All of the following conditions must be met to trigger a false interrupt:

1. Before servicing an interrupt from the thermal sensor, read and compare the processor thermal reading with the threshold limits (T_{HIGH} or T_{LOW}). Figures 2 and 3 provide basic flowcharts for the implementation of this workaround in an interrupt driven system.
2. If the firmware implemented polls the Status Register only, then before taking any action, re-read the temperature register and do a comparison with the alarm threshold limits (T_{HIGH} or T_{LOW}) to determine if the value is actually still within the temperature window.
