# **Intel® Desktop Board D865GRH Specification Update**

Release Date: November 2004

Order Number: C59427-007

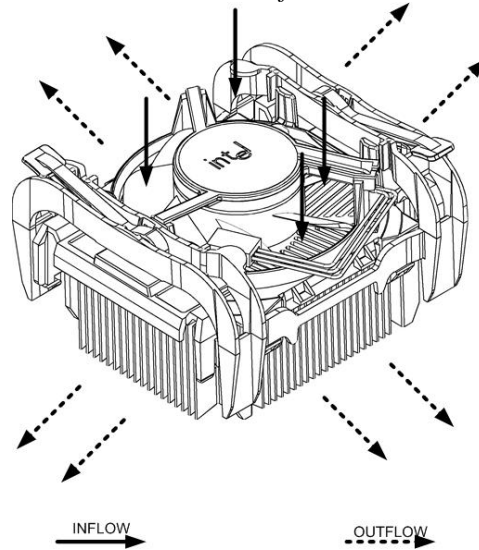
**Figure 25a. Omnidirectional Airflow Heatsink**

- *A chassis with a maximum internal ambient temperature of 38 Degrees Celsius*
- *A processor heatsink that provides omnidirectional airflow so that air is drawn across the processor voltage regulator area (item A in Figure 26). Figure 25a illustrates an omnidirectional airflow heatsink.*

*Failure to ensure appropriate airflow may result in reduced performance of both the processor and/or voltage regulator or, in some instances, damage to the desktop board. For a list of chassis that have been tested with Intel® desktop boards please refer to the following website:*
