Mobile Intel[®] Pentium[®] II Processor Specification Update

Release Date: December 2006

Order Number: 243887-057

The Mobile Pentium[®] II processor may contain design defects or errors known as errata which may cause the product to deviate from published specifications. Current characterized errata are documented in this Specification Update.

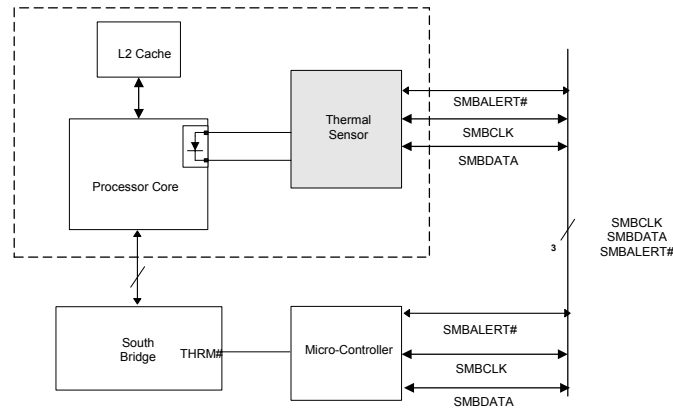
Figure 1. An Example of Microcontroller Driven Thermal Management

B30. Thermal Sensor May Assert SMBALERT# Incorrectly

Problem: The Mobile Pentium II processor and the Pentium II Processor Mobile Module have a thermal sensor that monitors the processor core's temperature. Please note that desktop systems could have a similar thermal device. The thermal sensor asserts SMBALERT# if the processor temperature exceeds the temperature limits set in the Alarm Threshold Registers (T_{HIGH} , T_{LOW}). It also sets the corresponding Status Register bits to identify the cause of the interrupt. Figure 1 gives one example of the how the SMBALERT# signal could be used in a system.

Under the conditions described below, the thermal sensor incorrectly generates the SMBALERT# interrupt. All of the following conditions must be met to trigger a false interrupt:
