Intel® Desktop Board D865GLC Specification Update

Release Date: November 2004

Order Number: C41598-012

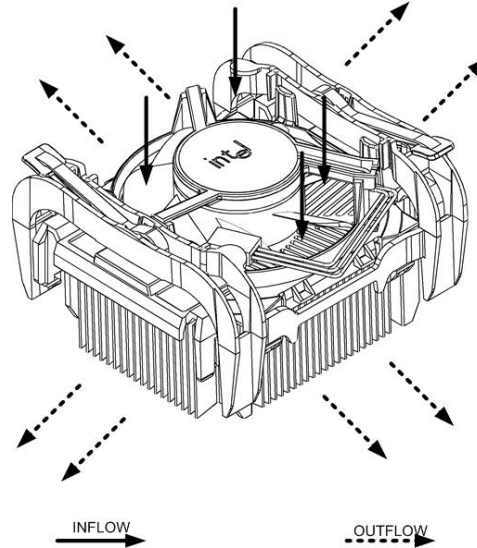
Figure 29a. Omnidirectional Airflow Heatsink

- A chassis with a maximum internal ambient temperature of 38 Degrees Celsius
- A processor heatsink that provides omnidirectional airflow so that air is drawn across the processor voltage regulator area (item A in Figure 30). Figure 29a illustrates an omnidirectional airflow heatsink.

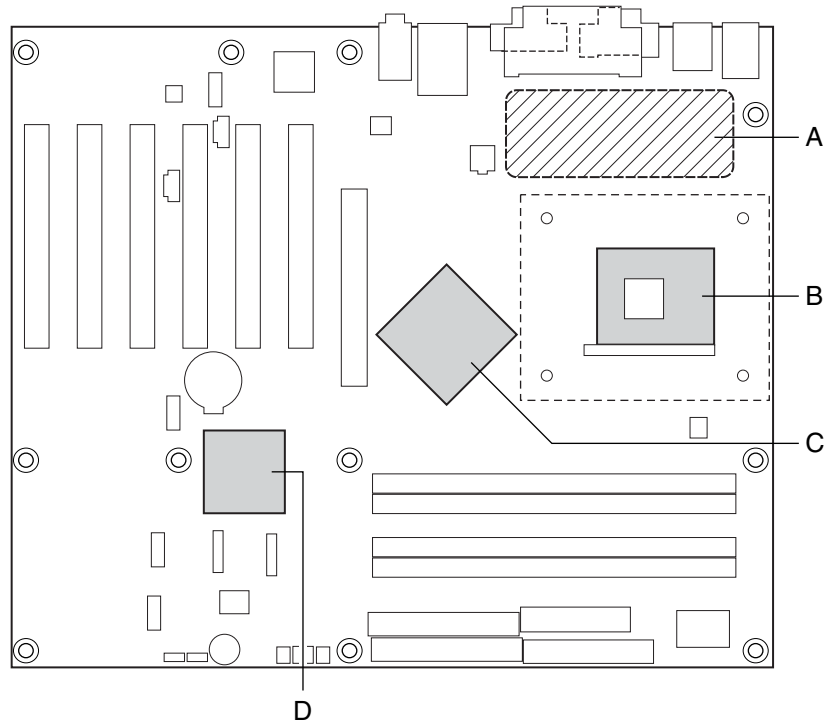
Figure 30. Localized High Temperature Zones

Figure 30 shows the locations of the localized high temperature zones.

Item	Description
A	Processor voltage regulator area
B	Processor
C	Intel® 82865G GMCH
D	Intel® 82801EB ICH5

Ensure that proper airflow is maintained in the processor voltage regulator circuit. Failure to do so may result in damage to the voltage regulator circuit. The processor voltage regulator area (item A in Figure 30) can reach a temperature of up to 85 °C in an open chassis.
