# **Intel<sup>®</sup> Core<sup>™</sup> Duo Processor and Intel<sup>®</sup> Core<sup>™</sup> Solo Processor on 65 nm Process**

**Specification Update**

***Revision 019***

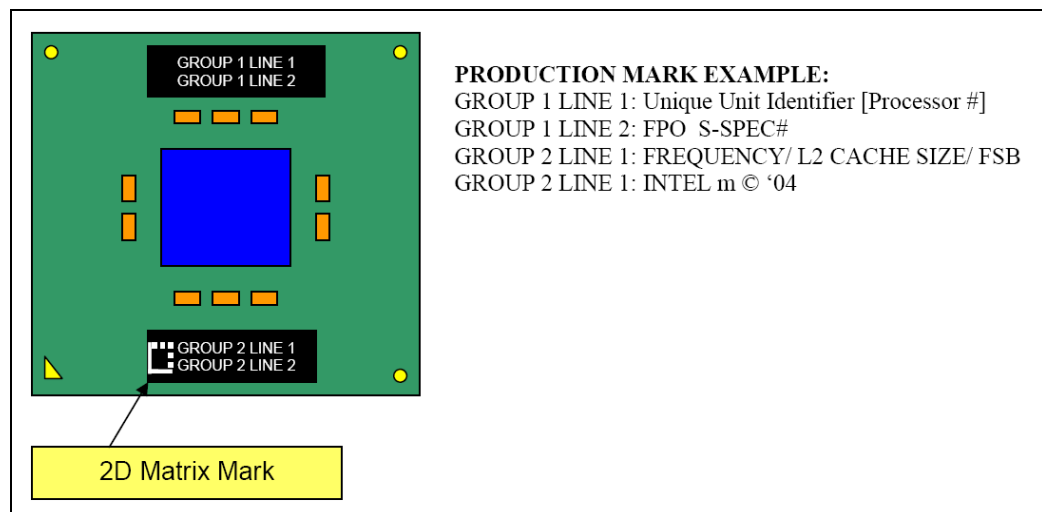
**Figure 1. Intel® Core™ Duo Processor and Intel® Core™ Solo Processor on 65 nm Process (Micro-FCPGA/FCBGA) S-Spec Markings**
