# 64-bit Intel<sup>®</sup> Xeon<sup>®</sup> Processor with 800 MHz System Bus (1 MB and 2 MB L2 Cache Versions)

Specification Update

*August 2008*

Order Number: 302402-023

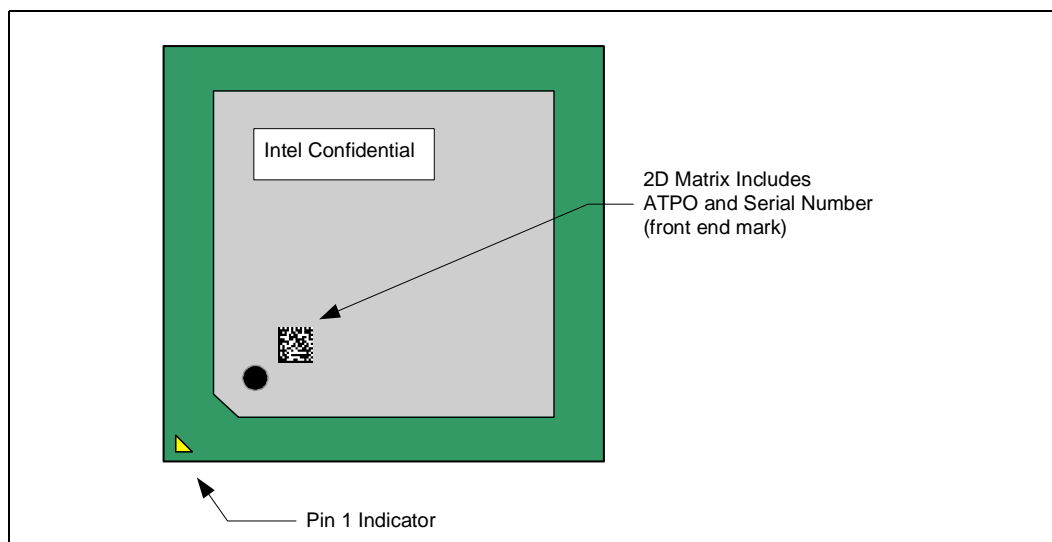
Figure 2-1. Top-Side Processor Marking Example

## 2.1 64-bit Intel® Xeon® Processor with 800 MHz System Bus (1 MB and 2 MB L2 Cache Versions) Package Markings (604-pin FC-mPGA4 Package)
